ANTARES MECHANICS: A CRITICAL ANALYSIS IN VIEW OF A LARGE SCALE DETECTOR

ANTARES: overview of the layout

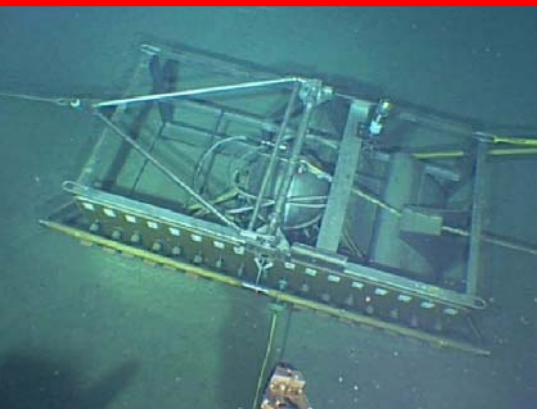
ANTARES: undersea infrastructure

THE JUNCTION BOX

- 500 dm³ TITANIUM CONTAINER (2 EMISPHERICAL CAPS + INTERMEDIATE CYLINDRICAL SPACER)
- 2 COMPARTMENTS: UPPER (DRY) WITH ELECTRONICS, LOWER (OIL-FILLED) WITH TRANSFORMER
- TITANIUM FRAME WITH FIBREGLASS PANELS TO HOLD ODI WET-MATEABLE CONNECTORS
- FEATURES TO DEPLOY AND RECOVERY WITHOUT A ROV/SUBMARINE
- 16 OIL-FILLED PRESS-BALANCED JUMPERS+WET-MATEABLE CONNECTORS

INTERLINK CABLES

- 4 OPTICAL FIBRES + 2 COPPER CONDUCTORS, WET-MATEABLE
- OPERATION UP TO 500 V / 5 A
- LENGTHS RANGING FROM 120 TO 350 m
- DRY CABLES, 100 MATING OPERATIONS WITHOUT MAINTENANCE

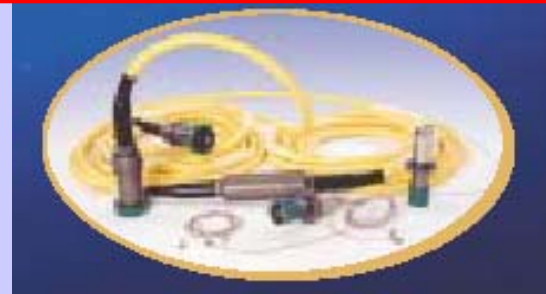
- STANDARD ALCATEL CABLE, 42 Km LONG
- STEEL ARMoured, DOUBLE ARMoured FOR 15 Km, DOWN TO 1000 m DEPTH
- 48 OPTICAL FIBRES +COPPER CONDUCTORS,
- GROUND RETURN THROUGH SEA ANODE ON JB
- RATED AT 30 KV - 50 A
- SEACON DRY-MATEABLE CONNECTOR TO JUNCTION BOX

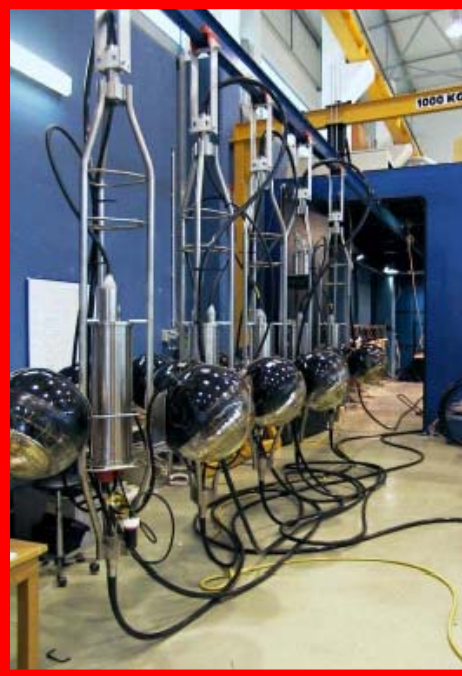
THE STOREY

- TITANIUM GRADE 2 WELDED FRAMEWORK HOLDING LCM CONTAINER AND 3 OPTICAL MODULES
- LCM CONTAINER MADE OUT OF TITANIUM GRADE 5, CYLINDRICAL BODY 179x157mm DIA + END FLANGES
- OPTICAL MODULES HOUSING PMT, ELECTRONICS, MU-METAL CAGE AND OPTICAL GEL INSIDE A GLASS SPHERE AND FASTENED TO THE OMF VIA A TITANIUM GRADE 2 WIRE STRUCTURE

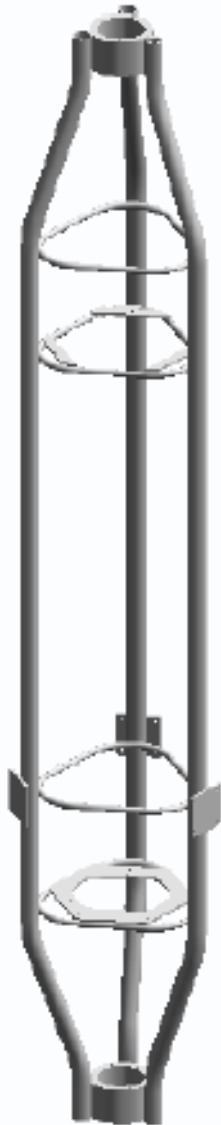
ANTARES: further line details

**REMARK THE
COMPLEXITY OF
THESE ITEMS**

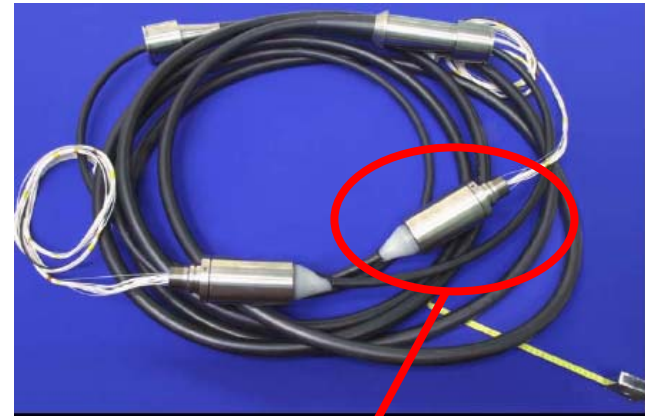
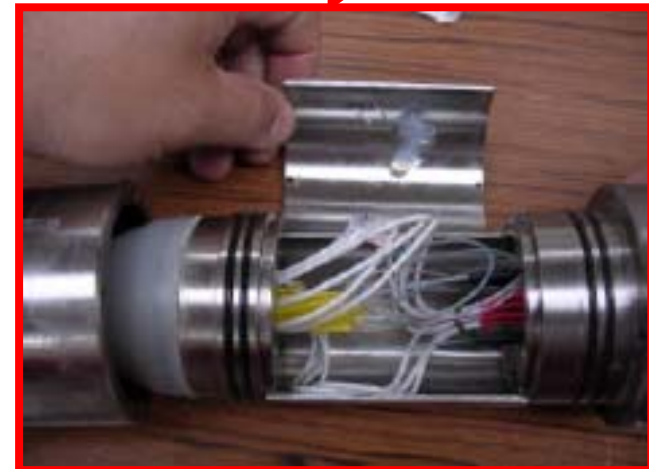
EMC CABLE BUDGET COST BREAKDOWN

- THE LARGEST CONTRIBUTION TO THE OVERALL COST COMES FROM THE “**WATER-BLOCKED**” PENETRATOR, THAT PREVENTS WATER TO ENTER INTO THE CONTAINERS THROUGH THE CABLE

- A “NON WATER-BLOCKED” PENETRATOR IS DEFINITELY MUCH SIMPLER AND EASIER TO INTEGRATE, AND ALLOWS EMC COST REDUCTIONS OF ABOUT **40%**

- A GOOD COMPROMISE IS TO FORESEE SECTIONS HYDRAULICALLY ISOLATED TO THE NEIGHBORING ONES (AS IN A SHIP) SO THAT, IF SOME SECTIONS GET FLOODED, THE DETECTOR CAN KEEP OPERATIVE WITH AN ACCEPTABLE LOSS OF PERFORMANCE
